Manhole Inspection Summary

Manhole # S4300_016MH

Insp Date: **12/14/07 10:11 AM**

Location Address: **Darley Ave**

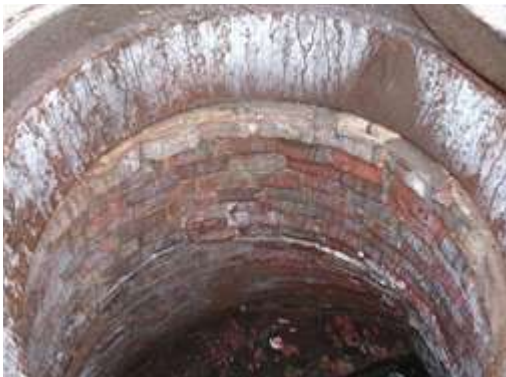
Defect 1

Frame Offset: **1** (in.) Condition: ☐ Sound ☐ Cracked ☒ **Leaks**

Condition: ☐ Sound ☒ **Cracked** ☐ Root Intrusion ☐ Loose Brick ☐ Deteriorated

Infiltration: ☐ None ☒ **Joint** ☐ Cracks ☐ Mortar ☐ Roots ☐ Wall

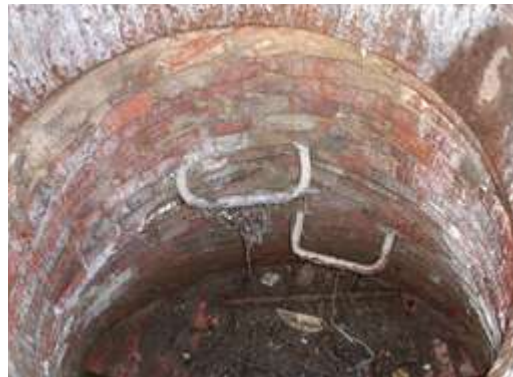
Defect 2

Infiltration: ☐ None ☐ Joint ☐ Cracks ☐ Mortar ☐ Roots ☒ **Wall**

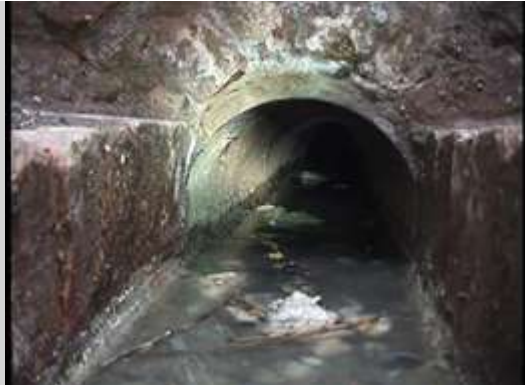
12 O'Clock Outflow

8 in. Circular Gravity Sewer
Pipe Out @ 12 O'Clock

Pipe Height: **8.4** (in.) Rod and Bar (Angled)
Pipe Material: **Clay** ☐ Pipe Lined
Invert Depth: **5.61** (ft.) Flow Characteristics: **Slow**
Deposits: ☒ None ☐ Mud ☐ Sludge ☐ Debris ☐ Grease
Silt Depth: (in.) Deposits Extent:
Infiltration: **None** Pipe Seal Cond: **Sound**

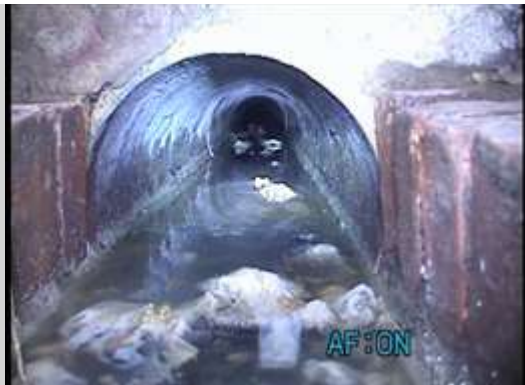
5 O'Clock Inflow

8 in. Circular Gravity Sewer
Pipe In @ 6 O'Clock

Pipe Height: **8.4** (in.) Rod and Bar (Angled)
Pipe Material: **Clay** ☐ Pipe Lined
Invert Depth: **5.62** (ft.) Flow Characteristics: **Slow**
Deposits: ☒ None ☐ Mud ☐ Sludge ☐ Debris ☐ Grease
Silt Depth: (in.) Deposits Extent:
Infiltration: **None** Pipe Seal Cond: **Sound**
